## Development of Visual Inspection for Plastics using Image Processing Technique

*This report describes the development of quality inspection of plastic products by using an 'image processing technique'. The objective of this research is to reduce the occurrence of defect plastic parts in the production line. A visual inspection is carried out prior to the production line using a dot template film to compare black dot sizes during which there is the possibility for defect parts to leak into the production line. A Fish Bone Diagram was used to analyze the primary cause of the inspection error and a Matrix Diagram was used to calculate the relative scores between cause and effect. We found the three main causes of the problem, which are eye strength, misalignment when film is deposited on parts and light quality. Then a 'Why Why' Analysis was used for the analysis of the root cause of the problem and an image processing technique was applied for error observation as opposed to a film template. For making a decision easily, the defect part is divided into two types, a black dot size on a plastic part being smaller than 0.2 mm. and a black dot size on a plastic part being bigger than

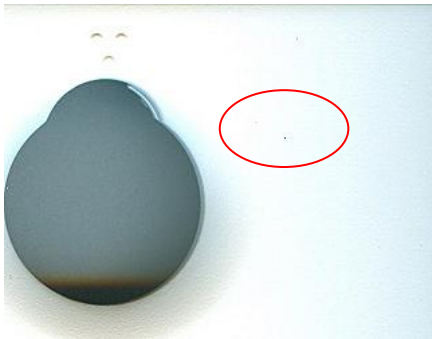
(A) Accepted parts, Black dot dimension not bigger than 0.2 mm

1. If the black dot dimension is smaller than 0.2 mm., the plastic parts will be accepted.
2. If the black dot dimension is bigger than 0.2 mm., the plastic parts will be rejected.

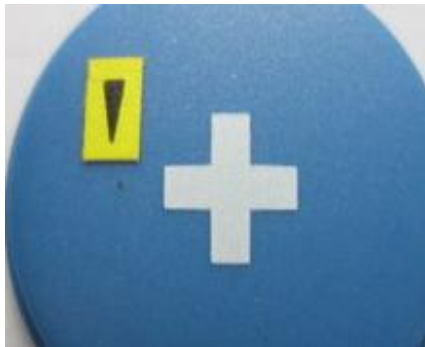
(B) Rejected parts, Black dot dimension bigger than 0.2 mm.

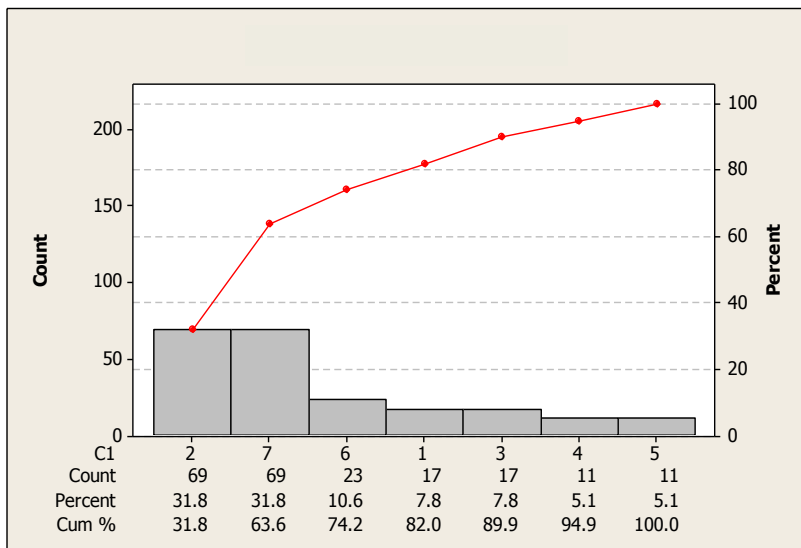
\* Remark:

- 1 = Inspection times
- 2 = Eyesight exhausted
- 3 = Uncertain
- 4 = Interesting
- 5 = Concentration
- 6 = Lightness
- 7 = Placing film wrong position

According to the fish bone diagram, that can be written to matrix diagram to show relative between cause and effect, and arrange influence factors which effect to customer behavior by giving scores. As shown in table 2. Moreover, there is Pareto diagram which also explains significant and insignificant of different as shown in Figure 2.

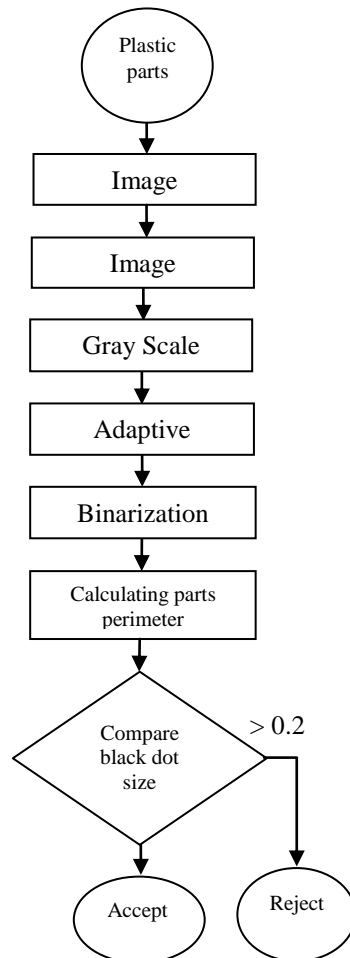
**Figure 3:** Flowchart of black dot inspection by prototype program

To finding a boundary of black dot in testing process is as follow in figure 3.

The structure of the program is divided following function process by started from image acquisition, enhancement images, and black dot segmentation; determine conference number of parts, and calculating parts perimeter. Finally grouping parts by black dot size, those are bigger or equal to 0.2mm., and smaller or equal to 0.2mm. As shown in figure 3.

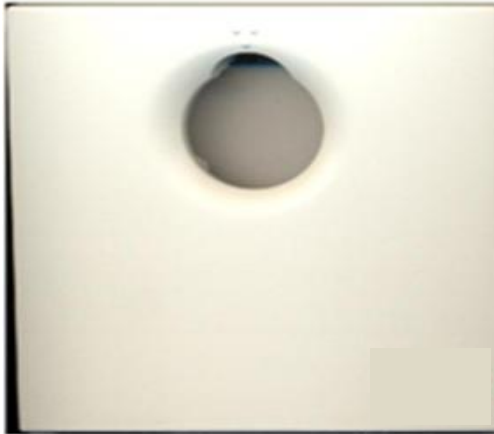
Figure 4: Image acquisition

The process of scanning images using a scanner to sweep image and get a 2D (2 dimensions) image. As shown in Figure 4. Then, the signal converter from analog to digital signal and analysis all images by Matlab software v.7. The detail of specific pieces of front surface part only, and adjust the perpendicular piece and all planes to the accuracy of processing program.

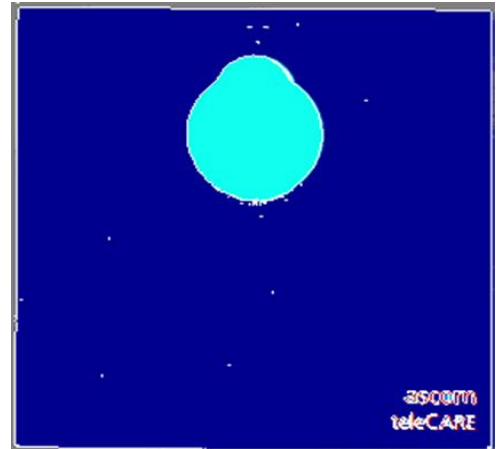
Figure 6: Result of black dot segmentation

This process was important to identify the black dot which find boundary area and indentify symbol in each dot. As shown in Figure 6.

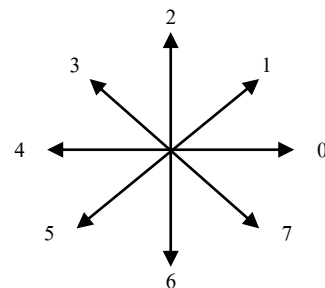
Figure 7: Finding 8-connectivity

For the process of finding the boundary of black dot using Inner Boundary Tracing [8]. Find contour the border of pixel in 8- connectivity, as shown in figure 7 search 8 directions is determine to be define the direction from 0-7.

$$\text{Perimeter} = (\text{number of borders in direction } 0 \ 2 \ 4 \ \text{and } 6) + \dots \dots \dots \quad (\text{Figure 7})$$

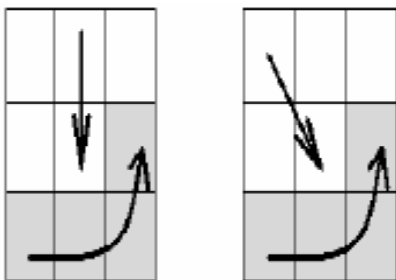
Figure 8: Inner boundary tracing: search sequence in 8-connectivity

The figure 8 is example of finding border using Inner Boundary Tracing follow step above. The first pixel is pixel  $P_0$ . Then search in pixel positioned in direction follow step 2 found pixel  $P_1$  and border direction from  $P_0$  to  $P_1$ , direction is 0. (Figure 7), consideration of the surrounding pixels  $P_1$  follow step 2 and the next pixel is  $P_2$ . The direction of border from  $P_0$  to  $P_1$ , direction is 7. (as shown in figure 7) Update the dir value until the condition in step 4 and pixel of image are  $P_0 P_1 P_3 P_4 P_5 P_6 P_7 P_8 P_9$  and  $P_{10}$

(dir+7) mod 8 if dir is even. (Figure 8)  
 (dir+6) mod 8 if dir is odd. (Figure 8)

From sample in figure 8 the borders in direction 0 2 4 and 6 including the border of pixel  $P_0$  to  $P_1$ , pixel  $P_2$  to  $P_3$ , pixel  $P_5$  to  $P_6$ , pixel  $P_6$  to  $P_7$ , pixel  $P_7$  to  $P_8$  and pixel  $P_9$  to  $P_{10}$ , all 6 borders. The borders in direction 1 3 5 and 7 including the border of pixel  $P_1$  to  $P_2$ , pixel  $P_3$  to  $P_4$ , pixel  $P_4$  to  $P_5$ , pixel  $P_8$  to  $P_9$ , pixel  $P_{10}$  to  $P_0$ , all 4 borders. Therefore, the length of perimeter of the figure 9 can be calculated as follow.

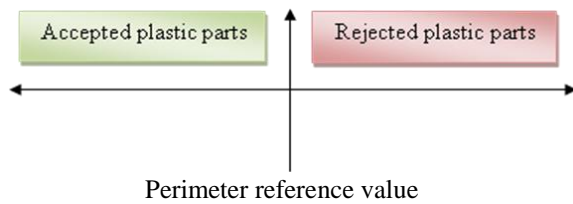
**Figure 10:** Range of perimeter reference value and plastic part separating

The perimeter length was calculated to compare of perimeter value of black dot standard. To separated the type of black dot with the following classification as.

1. If length of black dot perimeter is less than reference value, the plastic part will be accepted.
2. If length of black dot perimeter is more than reference value, the plastic part will be rejected.

The result of experiment by measure 30 accepted parts, found that their perimeters are nearly and the value are not much difference. The lowest reference perimeter is 7.900 units and the highest is 8.367 units.

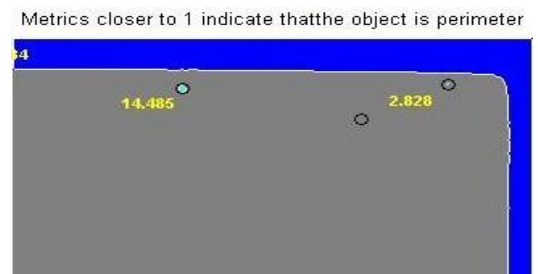
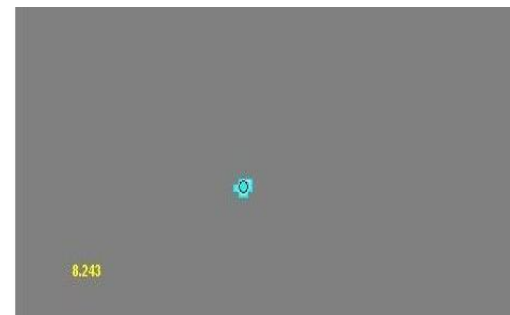
**Figure 11:** The picture shown sample result of experiment by use image processing technique

Due to prototype program testing, the black dot dimensions were measured correctly so the program is applied to use for GPV incoming inspection. The sample result of experiment as shown in the Figure 11. Following one month observation, the plastics parts 10,500 pieces from 14 lots were 100% checked as per work inspection of plastic parts model AS28114R except black dot inspection that were checked by the program. The accepted parts from this method will be marked inside of parts before send to manufacturing process. As a result the operators can detect parts at incoming inspection very lots and there is 0.11% or 12 over size black dot plastic parts escape to production line. From investigation, those parts were not inspection by the program.
